DEPARTMENT OF TRANSPORTATION**DIVISION OF ENGINEERING SERVICES**

Quality Assurance and Source Inspection

Contract #: 04-0120F4Cty: SF/ALA Rte: 80 PM: 13.2/13.9File #: 69.28**WELDING INSPECTION REPORT****Resident Engineer:**Pursell, Gary**Address:** 333 Burma Road**City:** Oakland, CA 94607**Report No:** WIR-002400**Date Inspected:** 18-May-2008**Project Name:** SAS Superstructure**OSM Arrival Time:** 630**Prime Contractor:** American Bridge/Fluor Enterprises, a JV**OSM Departure Time:** 1630**Contractor:** Zhenhua Port Machinery Company, Ltd (ZPMC), Changxing Island **Location:** Shanghai, China**CWI Name:** Lvliqing and Zhang Bao Lei**CWI Present:** Yes No**Inspected CWI report:** Yes No N/A**Rod Oven in Use:** Yes No N/A**Electrode to specification:** Yes No N/A**Weld Procedures Followed:** Yes No N/A**Qualified Welders:** Yes No N/A**Verified Joint Fit-up:** Yes No N/A**Approved Drawings:** Yes No N/A**Approved WPS:** Yes No N/A**Delayed / Cancelled:** Yes No N/A**Bridge No:** 34-0006**Component:** OBG And SAS Tower Fabrication**Summary of Items Observed:**

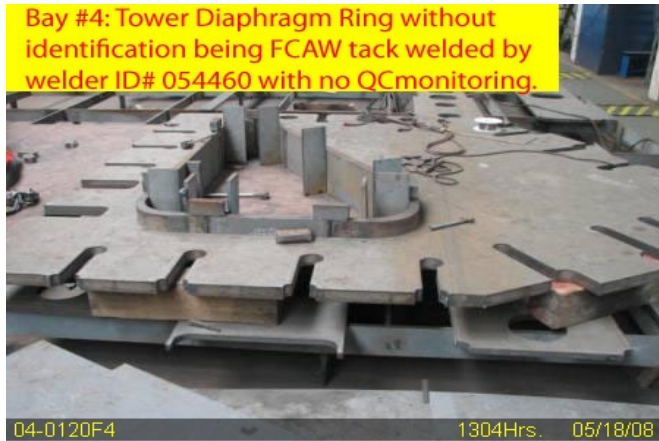
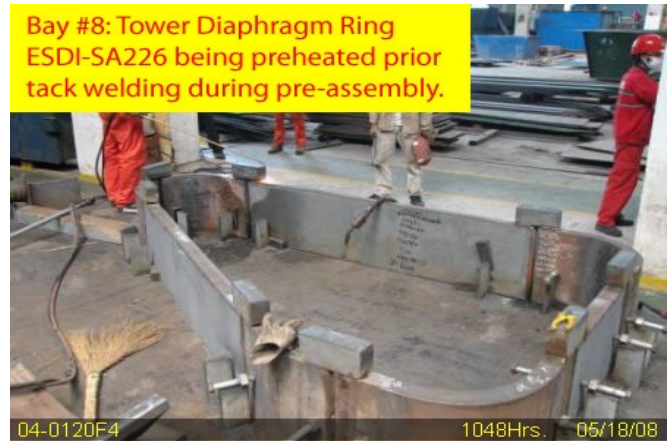
with the aid of hydraulic ram and welded jig. These plates are intended for diaphragm ring that will be spliced together. The procedure HSR1(T)-1212 is being followed and heat input is monitored by ZPMC QC of less than 650 degree C.

Bevel cutting on various heavy plates without visible marking intended for diaphragm ring is also on going in this bay.
